Qualitative and Quantitative Assessment of Metal Artifacts Arising from Implantable Cardiac Pacing Devices in Oncological PET/CT Studies: A Phantom Study

Purpose: We evaluate the magnitude of metallic artifacts caused by various implantable cardiac pacing devices (without leads) on both attenuation maps (μ -maps) and positron emission tomography (PET) images using experimental phantom studies. We also assess the efficacy of a metal artifact reduction (MAR) algorithm along with the severity of artifacts in the presence of misalignment between μ -maps and PET images.

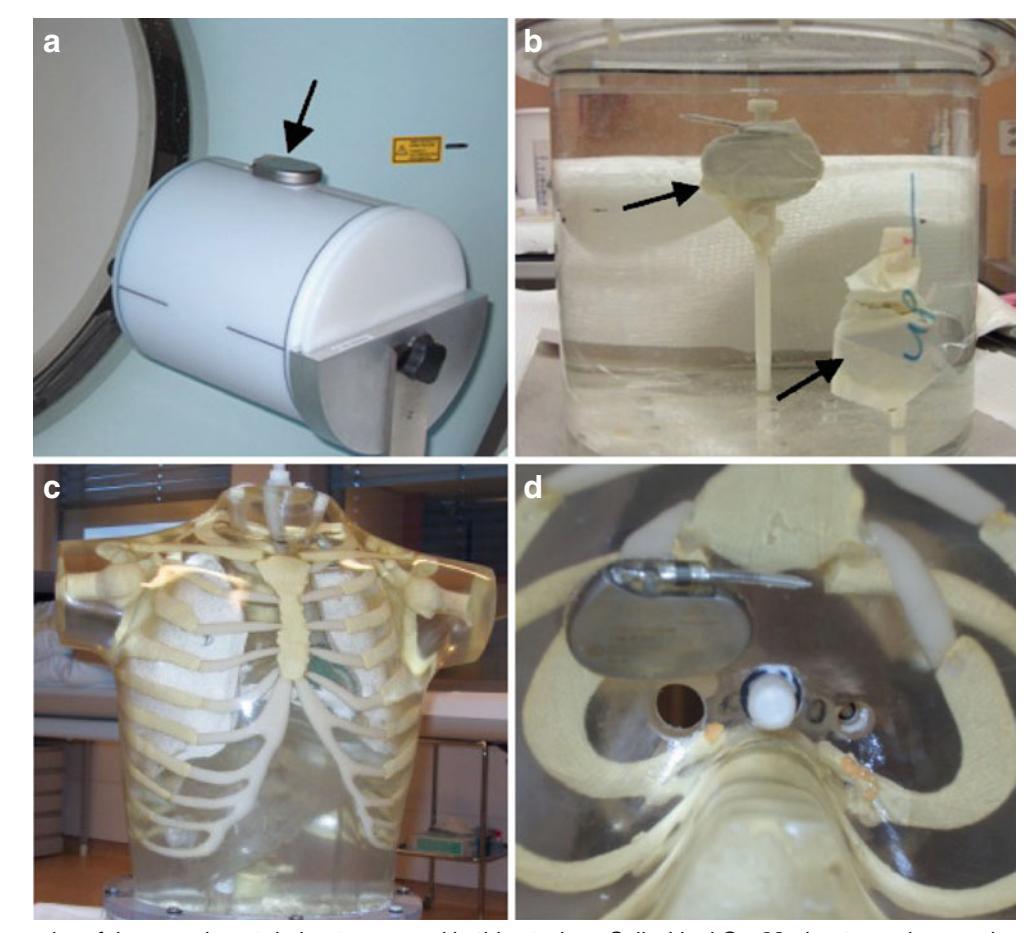
Fig. 1. Photographs of the experimental phantoms used in this study. **a** Cylindrical Ge-68 phantom where various pacing devices are attached to the outer side of the phantom. **b** Water-bath phantom containing pacemakers 1 and 2 on the *top* and *bottom*, respectively. **c** The RSD heart/thorax phantom in which pacemaker 1 was implanted under the right clavicle near the sternum (**d**).

Three phantoms including a solid cylindrical ⁶⁸Ge/⁶⁸Ga phantom, a water-bath phantom and the anthropomorphic heart/thorax phantom (Radiology Support Devices, Inc.) were used in this study.

Moreover, two pacemakers, namely pacemaker 1 (Actros SR Model 120082, Biotronik, Inc.) and pacemaker 2 (Meridian DR Model 1276, Guidant, Inc.) along with two cardiac resynchronization therapy (CRT) devices including a CRT defibrillator-CRT-D (InSync Marquis model 7277, Medtronic, Inc.) and a CRT pacemaker-CRT-P (InSync III Model 8042, Medtronic, Inc.) were used in this study (Fig. 1). For the first phantom, each device was separately attached to the outer side of the uniform cylindrical phantom (22 cm diameter) containing 74 MBq of ⁶⁸Ge/⁶⁸Ga (Fig. 1a). The visual assessment demonstrated the strongest artifacts when using pacemaker 1 and the weakest when using CRT-P. Therefore, in the second phantom (Fig. 1b), pacemaker 1 and CRT-P were placed inside a uniform water-filled cylinder (20 cm in diameter) containing 37 MBq of Fluorine-18. To emulate typical metallic artifacts in a pacemaker-bearing patient, pacemaker 1, which showed the strongest artifacts in the previous phantom study, was implanted under the right clavicle (Fig. 1c) of the RSD heart/thorax phantom (Fig. 1d). This tissue-equivalent anthropomorphic phantom is primarily designed for cardiac imaging studies and includes a typical human thorax, heart, lungs and liver. To model typical 2-deoxy-2-[¹⁸F]fluoro-D-glucose distribution in the human body, the phantom's individual organs were filled with Fluorine-18 approximately 1 h after 300-400 MBq administration of 2-deoxy-2-[¹⁸F]fluoro-D-glucose, as follows: 43.46 MBq in the thorax cavity, 5.71 MBq in the myocardial wall, 1.22 MBq in left lung, 1.74 MBq in right lung and 12.45 MBq in the liver [21].

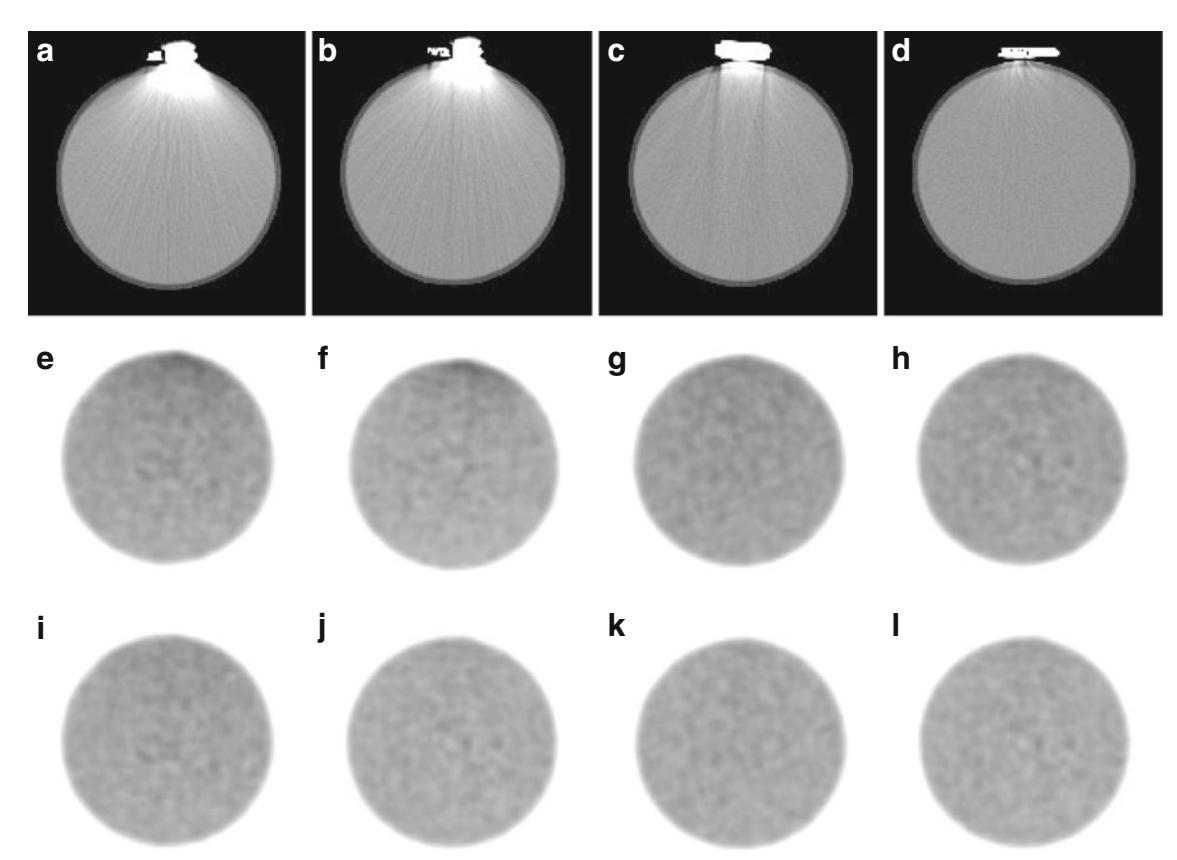
Fig. 2. Representative slices of the Ge-68 phantom study showing: original CT images (**a**–**d**), noMAR-AC PET images (**e**–**h**), and MAR-AC PET images (**i**–**l**), respectively. From *left* to *right*: pacemaker 1, pacemaker 2, CRT-D and CRT-P devices.

Figure 2 shows representative slices of CT and PET images of the Ge-68 phantom where the presence of cardiac pacing devices resulted in metallic artifacts on CT images and consequently, through CT-AC, on apparent tracer accumulation in the proximity of the devices in noMAR-AC PET images. Since the devices were attached to the outer wall of the phantom, only bright streak artifacts were dominantly produced and propagated downwardly into CT images. Table 1 summarizes the statistical analysis results of μ -maps and PET images comparing noMAR and MAR-mediated reconstructions for this phantom incorporating the four pacing devices used in this study. According to this table, the largest apparent uptake and LAC flare are brought by pacemaker 1 (37.7% and 24.7%, respectively) whereas the smallest apparent uptake and LAC flare are induced by the CRT-P device (8.2% and 2.3%, respectively). As presented in this table and observed in Fig. 2i–l, applying the MAR algorithm resulted in a reduction of the apparent increased uptake (P<0.0001) to the extent that there was no pseudo-uptake larger than 10% of the background, thus confirming the efficacy of the MAR algorithm in reducing bright streak artifacts. Likewise, statistical analysis revealed a significant difference (P<0.0001) between noMAR-AC and MAR-AC PET images for all metallic devices. It should be emphasized that the paired t test analysis comparing noMAR and MAR μ -maps or those of noMAR and MAR-AC PET images.

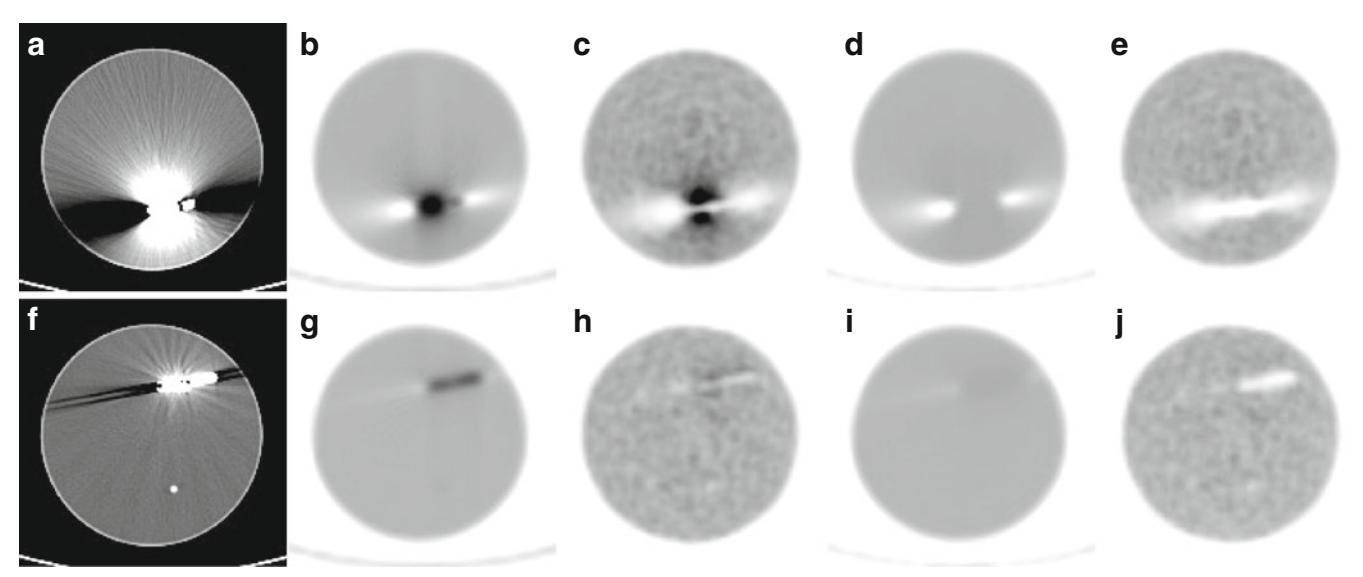
Fig. 3. Representative slices of CT images, μ -maps and PET images of the water-bath phantom for (**a**–**e**) pacemaker 1 and (**f**–**j**) CRT-P devices. From *left* to *right*: original noMAR CT images, noMAR μ -maps, noMAR-AC PET images, MAR μ -maps and MAR-AC PET.

Figure 3 shows representative slices of μ -maps, CT and PET images of the water-bath phantom. As can be seen, pacemaker 1 produced more severe bright and dark streak artifacts than CRT-P. As summarized in Table 2, this device resulted in a larger over- or underestimation of μ -maps and PET images. In the absence of MAR of CT images, the tracer uptake in the presence of pacemaker 1 and CRT-P was overestimated by 69.6% and 17.5% in flare regions and underestimated by 65.7% and 9.2% in photopenic regions, respectively. Likewise, linear attenuation coefficients in μ -maps near metallic devices were overestimated by 33.9% and 11.5% in flare regions and underestimated by 46.8% and 7.4% in photopenic regions, respectively. As shown

in Fig. 3d–e, i–j, the MAR algorithm considerably reduced the falsely increased LACs and tracer uptake in corresponding μ -maps and PET images but seems unsuccessful for compensation of the underestimations. The algorithm significantly reduced overestimations (P<0.0001) and underestimations (without proof of statistically significant difference in the latter case) of both LACs and tracer uptake (Table 2).

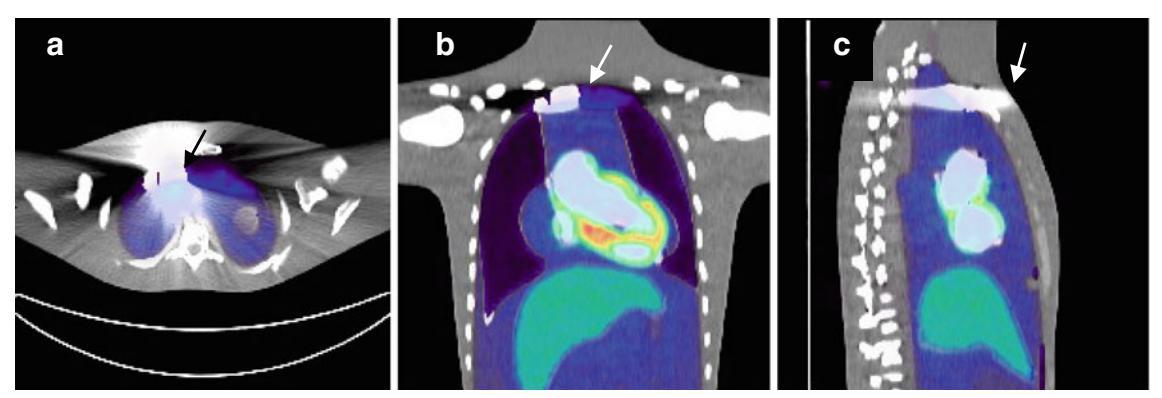
Fig. 4. PET/CT images of the RSD heart/thorax phantom showing bright and dark streak artifacts caused by pacemaker 1 displayed on **a** transverse **b** coronal, and **c** sagittal views.

The fused PET/CT image of the RSD heart/thorax phantom is shown in Fig. 4. The streak artifacts caused by pacemaker 1 have adversely affected a large area on the CT image which propagated into the PET image through the CT-AC procedure. As shown in Fig. 5a, d, the over- and under-correction by inappropriate linear attenuation coefficients resulted in artificially increased and decreased uptake in the vicinity of the implant on the noMAR-AC PET image. Compared with the uncorrected PET image (NAC-PET) shown in Fig. 5b, e, it turns out that the increased uptake mimicking pathology near the implant (black arrow in Fig. 5a, d) is artifactual. Moreover, the uptake in regions corresponding to dark streak artifacts (white arrow in Fig. 5a) has considerably falsely decreased which demonstrates that underestimation of tracer uptake has the potential to harbour small or low-uptake tumours in photopenic regions. On the MAR-AC PET images, the overestimations around the pacemaker were substantially

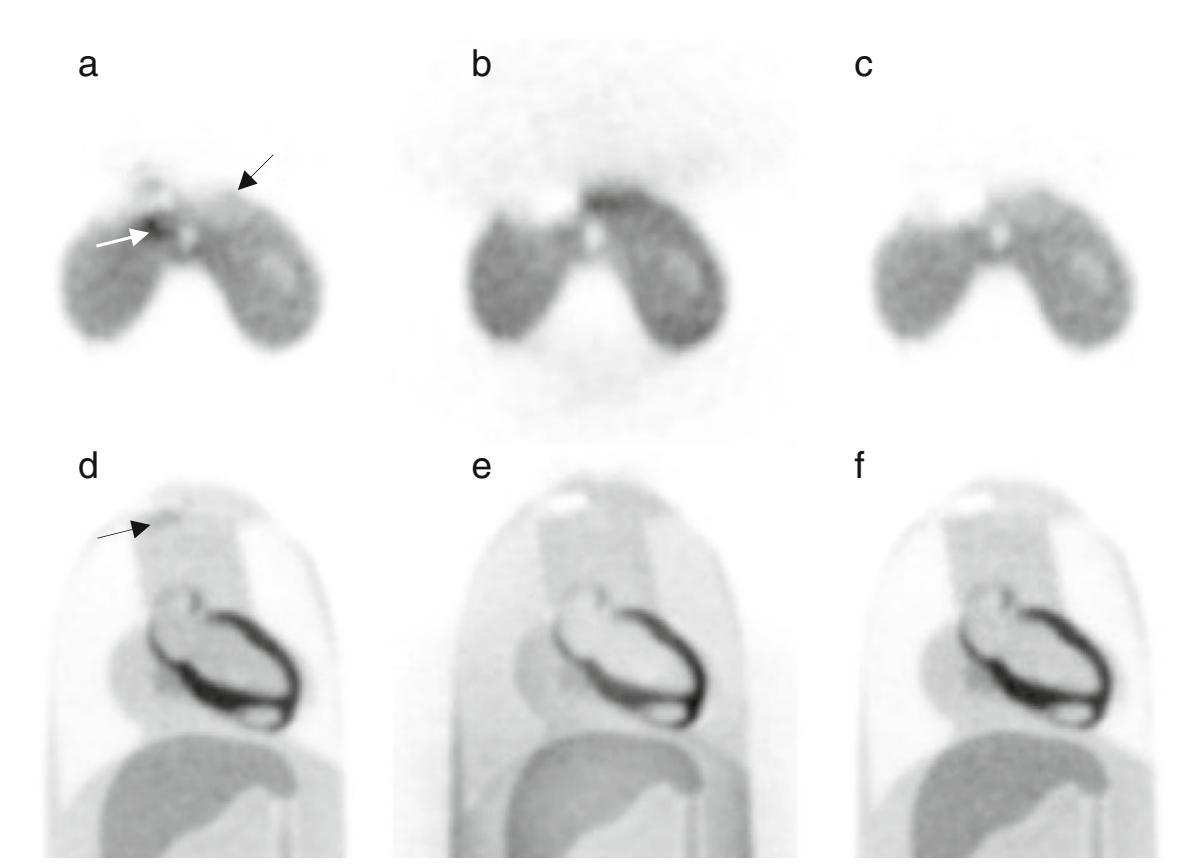
Fig. 5. a-c Transverse and d-f coronal views of a representative PET slice of the RSD heart/thorax phantom in the presence of pacemaker 1. From *left* to *right*: noMAR-AC PET images, NAC-PET images and MAR-AC PET images.

reduced; however, the underestimations remained visible (Fig. 5c, f). Figure 6 shows the effectiveness of the algorithm in reducing overestimated regions and in compensating underestimated ones on μ -maps and corresponding ACFs of the heart/thorax phantom.

observable uptake is seen, small uptake was observed at their corresponding location in noMAR-AC PET images (Fig. 5a). One possible explanation is the fact that 511 keV photons can interact with the pacemakers dominantly by Compton scattering and as such few counts can be detected at pacemaker's location. When these events are corrected by the overestimated LACs of pacemakers, they falsely appear as focal tracer uptake.

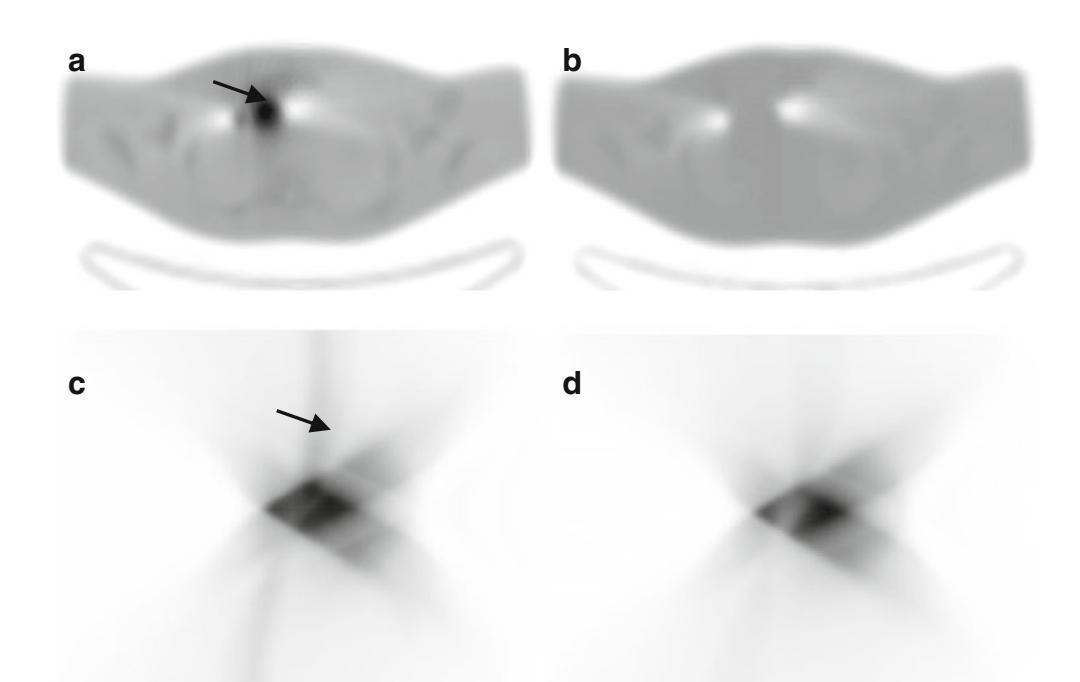
Fig. 6. Illustration of the performance of the MAR algorithm. Representative slices of noMAR (*left*) and MAR (*right*) μ -maps of the RSD heart/thorax phantom (**a**-**b**) and their corresponding ACFs (**c**-**d**).

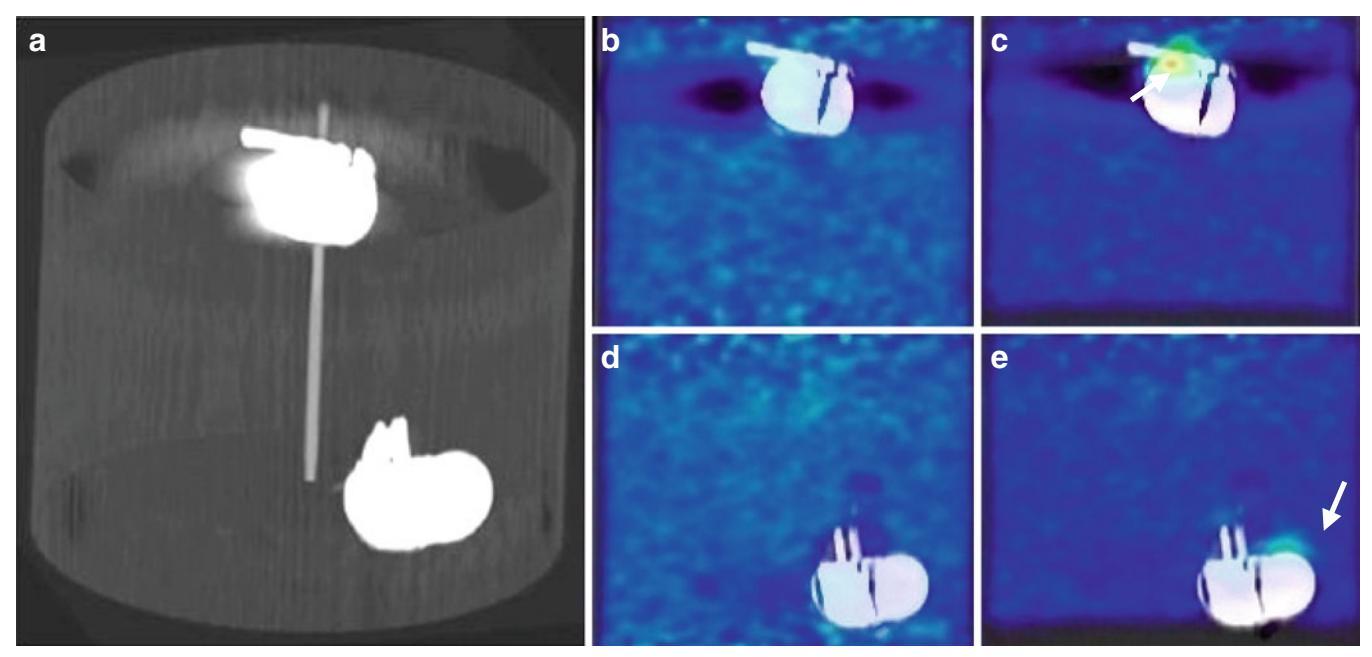
Fig. 7. Effect of misalignment between PET and CT images of the water-bath phantom. **a** A volumetric CT image in which the locations of pacemaker 1 (*top*) and CRT-P (*bottom*) are shown. **b** PET/CT image of pacemaker 1 corrected for attenuation using the aligned CT image, and **c** using misaligned CT image by 10 mm. **d** PET/CT image of the CRT-P device corrected for attenuation using aligned CT image and **e** using misaligned CT image by 10 mm.

Figure 7 shows fused PET/CT images of the water-bath phantom before and after 10 mm upward misalignment

between PET and CT images. In the presence of metallic objects such as pacemakers, if a misalignment occurs between a PET image and its corresponding μ -map, the high-attenuation coefficients corresponding to the location of the device are mistakenly used for attenuation correction of PET emission data in the vicinity of the device in the direction of misalignment which results in overcorrection for photon attenuation and consequently, overestimation of tracer uptake in these regions (Fig. 7c, e). In contrast, when PET images and their corresponding μ -maps are aligned, the artifactual increased uptake is not observed (Fig. 7b, d), although overestimation and underestimation of tracer uptake resulting from bright and dark streak artifacts arising from the device still remains a concern in both cases. Figure 8 shows the mean and peak tracer uptake (in kBq/cc) in artifactually metabolic regions around pacemaker 1 and CRT-P in the water-bath phantom, when PET and CT images are aligned (noMotion) and when they are misaligned (Motion). The results demonstrated that a 10 mm misalignment for pacemaker 1 causes an increase of the mean and peak activity concentration from 5.1 to 7.1 kBq/cc (P < 0.0001) and from 9.0 to 10.7 kBq/cc, respectively. Likewise, they increased from 3.4 to 4.3 kBq/cc (P<0.0001) and from 4.4 to 5.2 kBq/cc, respectively, for CRT-P.

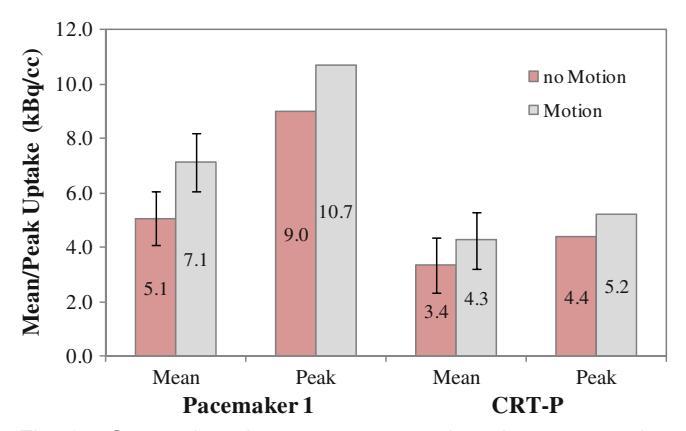
Fig. 8. Comparison between mean and peak tracer uptake in surrounding areas of pacemaker 1 and CRT-P device before (noMotion) and after (Motion) 10 mm upward misalignment between PET and CT acquisitions of the water-bath phantom.

According to the results presented in Fig. 8, it turns out that a misalignment between PET and CT images of the water-bath phantom produces an apparent increase in peak uptake by 18.8% for pacemaker 1 and 18.2% for CRT-P appearing as hot spots in PET images (Fig. 7c, e). Likewise, a misalignment by 10 mm upward resulted in 20.7% apparent increase in the peak tracer uptake for the heart/ thorax phantom nearby the pacemaker implant (Fig. 10). As mentioned earlier, when a misalignment occurs between the PET image and μ -map of a subject bearing a pacemaker or a defibrillator, the overestimated LACs of the device are partially applied to adjacent areas, thus producing hot spots and as such the effect of metal artifacts becomes more severe. Consistent with our study, various phantom studies reported a bias in activity concentration and uniformity in the presence of a metallic objects when motion occurs between PET and CT images [12, 13], which highlights the importance of immobilization aids and motion compensation algorithms.

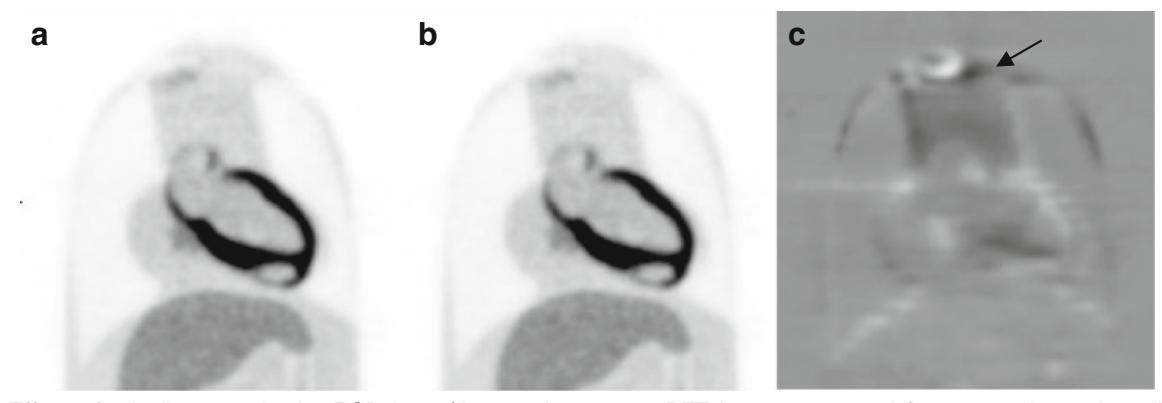
Fig. 9. Effect of misalignment in the RSD heart/thorax phantom. **a** PET image corrected for attenuation using aligned CT image and **b** using misaligned CT image by 10 mm. **c** The difference image (**a**-**b**) shows the increase of apparent uptake resulting from motion.

Figure 9 shows the impact of misalignment on the severity of artifactual uptake around pacemaker 1 in the heart/thorax phantom. The PET images shown in Fig. 9a–b were corrected for attenuation in the conditions of perfect alignment and 10 mm upward misalignment. The difference image is also shown in Fig. 9c where the influence of motion is observed as a noticeable apparent uptake in the vicinity of the implant. The ROI analysis presented in Fig. 10 shows that the mean uptake in active regions around the implant increased owing to the above-mentioned misalignment from 5.2 to 6.1 kBq/cc (P<0.0001) while the peak uptake increased from 5.8 to 7.0 kBq/cc.

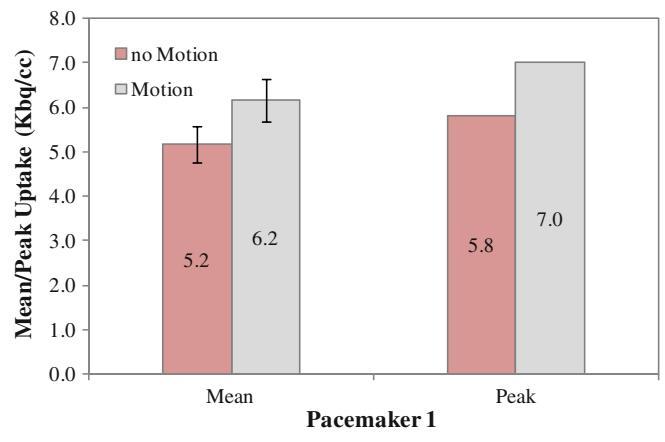
Fig. 10. Comparison of mean and peak tracer uptake in surrounding areas of pacemaker 1 before (noMotion) and after (Motion) 10 mm upward misalignment between the PET and CT acquisitions of the RSD heart/thorax phantom.
